Manhole Inspection Summary

Manhole # S03WW1014MH

Location Address: **6004 WALLIS AVE**

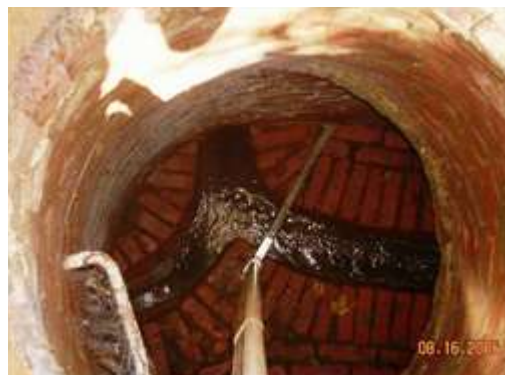
Top View

Adjustment, Corbel and Barrel infiltration.
Corroded steps. Evidence of surcharge -
Bench debris.

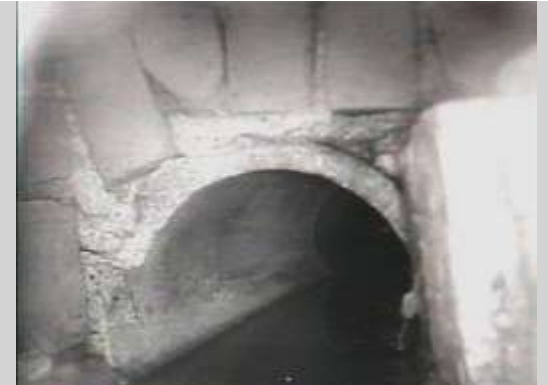
8 in. Circular Gravity Sewer Pipe Out @ 12 O'Clock

Deposits: ☐ None ☒ **Mud** ☐ Sludge ☒ **Debris** ☐ Grease

Silt Depth: **1** (in.) Deposits Extent: **Light**

Infiltration: **Evidence** Pipe Seal Cond: **Cracked**

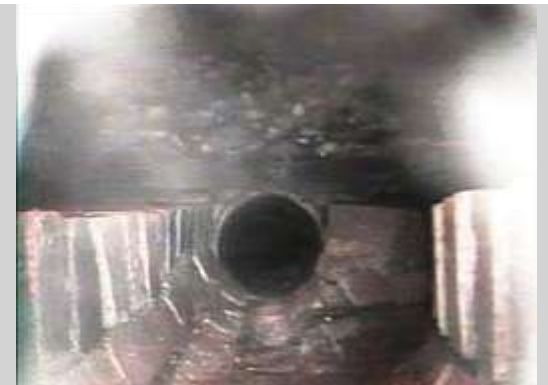
8 in. Circular Gravity Sewer Pipe In @ 3 O'Clock

Barrel deterioration and infiltration.

Infiltration: **Evidence** Pipe Seal Cond: **Unknown**

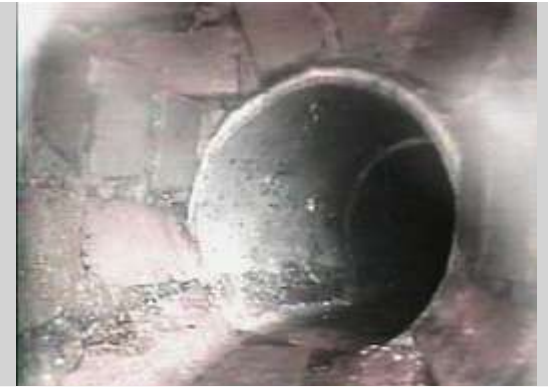
Pipe In @ 9 O'Clock

Infiltration: **Evidence**
